Restoring Kirk

Lessons in Midcentury Maintenance BY DALE KUTZERA

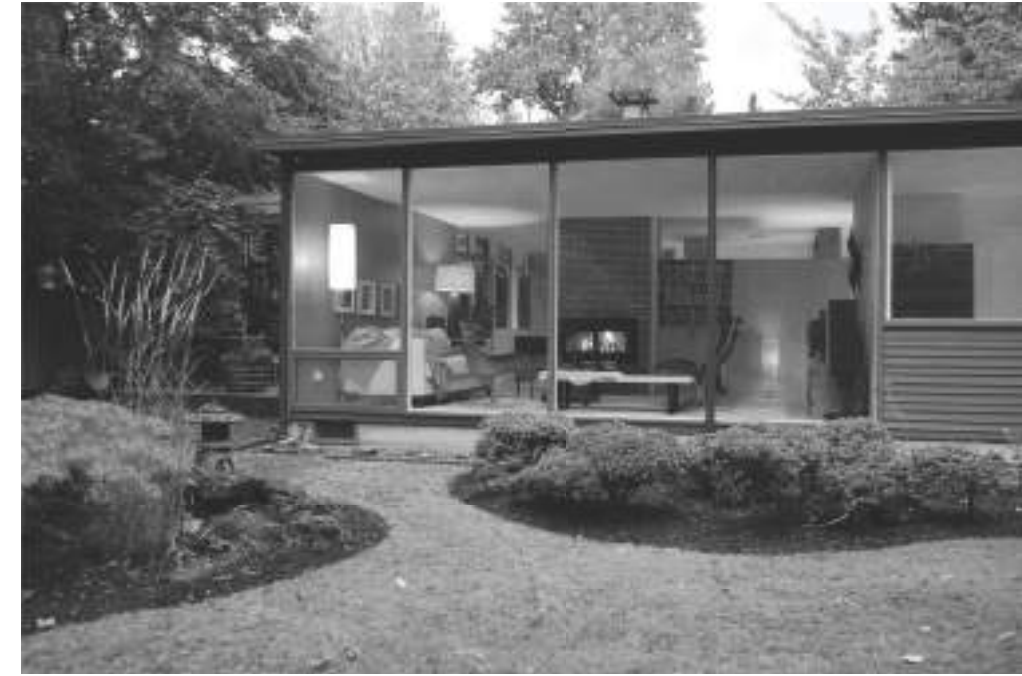
Paul Kirk's residential designs often feature flat roofs with thin profiles. Photo by Helen Hald

CHALLENGE #2: FLAT ROOFS Managing water is even more challenging when dealing with the flat roofs Kirk often designed in the 1950s.

"There is nothing wrong with a flat roof," noted Hald, "but you need a little positive drainage. Over time they can pond, and that adds weight and the structure sags. Then you have a permanent

pond. If you have a heavy-snow year, that can also cause some settlement."

New roofing systems can provide insulation and positive drainage while still maintaining a narrow profile. "Kirk wanted a thin profile on the roof edge," said Hald. "So one thing we use today is tapered rigid insulation so you still have the thin [fascia] line, and then as you move back, you start the taper so you don't see the thickness."

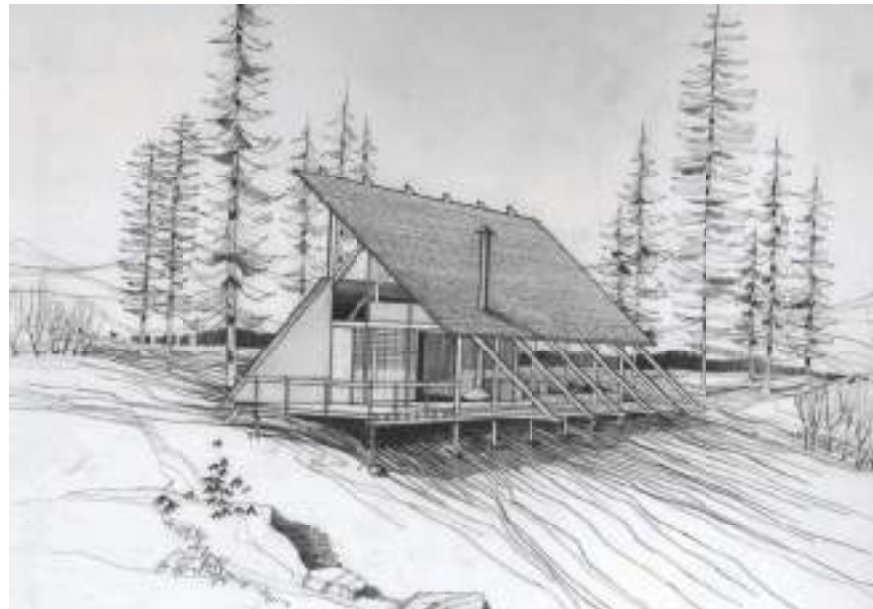
Sequim Cabin, Olympic Peninsula, WA. Drawing by Don Johnson of Kirk, Wallace, McKinley & Associates, courtesy of the University of Washington Libraries, Special Collections, UW38888

This is the exact situation facing Blake Williams, whose family co-owns a Kirk A-frame cabin on the Olympic Peninsula. One set of roof beams extends beyond the other, with both connected to floor joists outside the building and exposed to the elements. "This was a terrible idea," said Williams, who is also an architect. "sixty years later, water has crept in where steel

bolts connect the rafter beams to the horizontal beams, and the wood is rotting."

The solution was to transfer the weight of the roof away from the exterior joints. "We changed the path to the vertical posts by adding some steel structure under the whole cabin," explained Williams. "In effect we changed the way the structure carried the load."

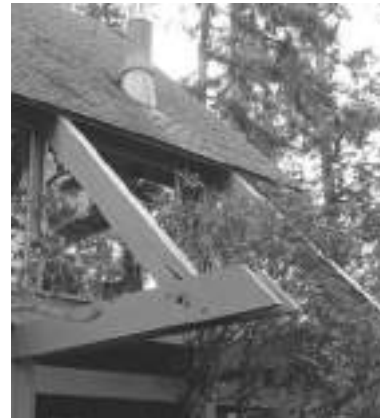
The exposed rafters and joists of the A-frame design have led to rot issues around bolted joints. Photo by Dale Kutzera

CHALLENGE #1: EXPOSED STRUCTURE "It can be difficult when the structure goes from inside to outside," said Hald, "because if the wood isn't protected and sealed and resealed over time—which a lot of people don't do—it's going to rot."
